## CONTEXTUALIZATION OF WORKING CONDITIONS IN THE RAILCAR WORKSHOP SECTOR OF A MINING INDUSTRY

This paper presents an ergonomic intervention related to wagon maintenance workstation, in a mining industry. It was performed interviews with workers, as well as field observations about the activities of the tasks and, also a questionnaire. In general, the results showed problems in order: environmental, Biomechanics and Organizational.

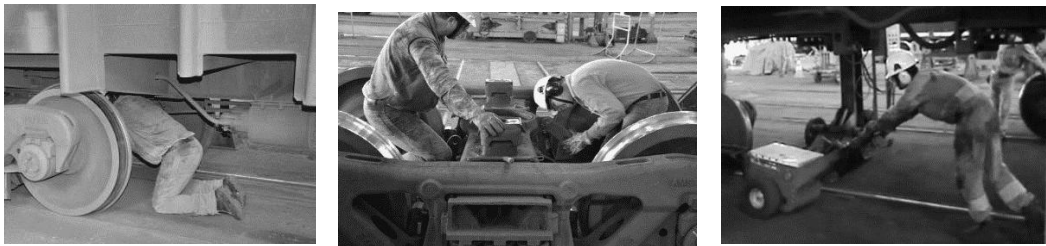
In various situations, improper postures were observed during the execution of tasks throughout the workday. These postures were particularly noticed during the removal of the cotter pin (a piece that secures some parts of the railcar and must be removed for the truck exchange operation), wheelsets, and traction exchange. It is worth noting both biomechanical/anthropometric and accident-related risks, as there was an imminent direct contact of mechanics with the accumulated iron ore under the railcars during the removal of the cotter pin.

Employees assume various postures during the operation, some of which require physical effort (Figure 1), such as: moving and removing parts of the railcar; using tools, moving parts, and equipment during the operation (for part removal, moving levers). And to turn the crank located beside the railcar, occasionally, the use of pieces arranged in the workplace is necessary to assist in freeing the part. This task requires physical effort from the employees.

**Figure 1: Examples of Inappropriate Postures**

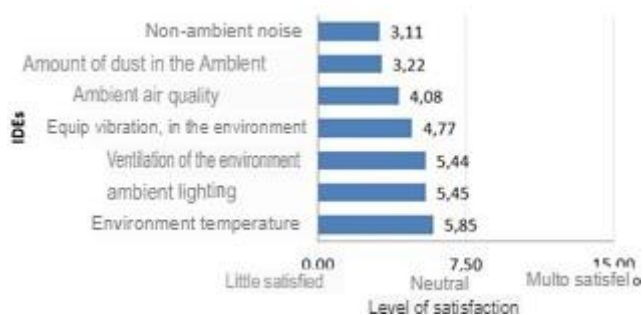
Regarding the questionnaire results, concerning the Environmental Construct (Figure 2), employees in the sector are dissatisfied with all Ergonomic Demand Items (IDEs), particularly with Noise, Dust, Air Quality, and Vibration.

**Figure 2 – Results of the Environmental Construct**

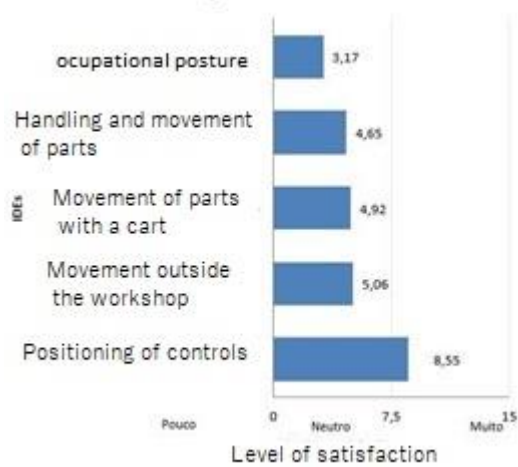
In the Biomechanics construct (Figure 3), it is evident that employees are dissatisfied with the occupational posture adopted during the performance of their activities, a fact highlighted during unsystematic observations.

**Figure 3 – Results of the Biomechanics Construct.**

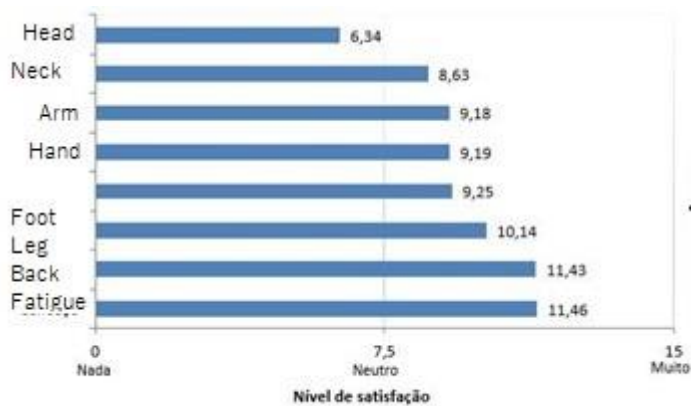
For the discomfort/pain construct (Figure 4), it is noticeable that, at the end of the shift, employees feel tired, with a high level of discomfort/pain in their backs. This level of discomfort can be corroborated by the posture adopted by employees, especially mechanics working underneath the railcars during cotter pin removal and part transportation.

**Figure 4 – Result of the discomfort/pain level.**
